**DEPARTMENT OF TRANSPORTATION**

Contract #: 04-0120F4Cty: SF/ALA Rte: 80 PM: 13.2/13.9File #: 69.28**WELDING INSPECTION REPORT****Resident Engineer:**Pursell, Gary**Address:** 333 Burma Road**City:** Oakland, CA 94607**Report No:** WIR-002776**Date Inspected:** 02-Jun-2008**Project Name:** SAS Superstructure**OSM Arrival Time:** 2300**Prime Contractor:** American Bridge/Fluor Enterprises, a JV**OSM Departure Time:** 800**Contractor:** Zhenhua Port Machinery Company, Ltd (ZPMC), Changxing Island **Location:** Shanghai, China**CWI Name:** Xu Le Feng**CWI Present:** Yes No**Inspected CWI report:** Yes No N/A**Rod Oven in Use:** Yes No N/A**Electrode to specification:** Yes No N/A**Weld Procedures Followed:** Yes No N/A**Qualified Welders:** Yes No N/A**Verified Joint Fit-up:** Yes No N/A**Approved Drawings:** Yes No N/A**Approved WPS:** Yes No N/A**Delayed / Cancelled:** Yes No N/A**Bridge No:** 34-0006**Component:** Tower**Summary of Items Observed:**

**New Tower Shop Bay 1:**

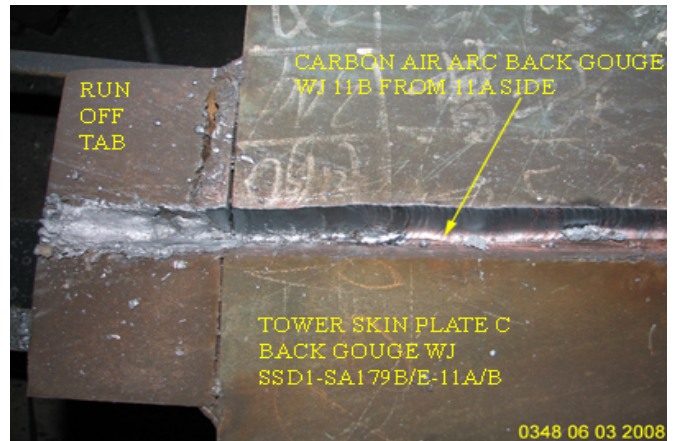
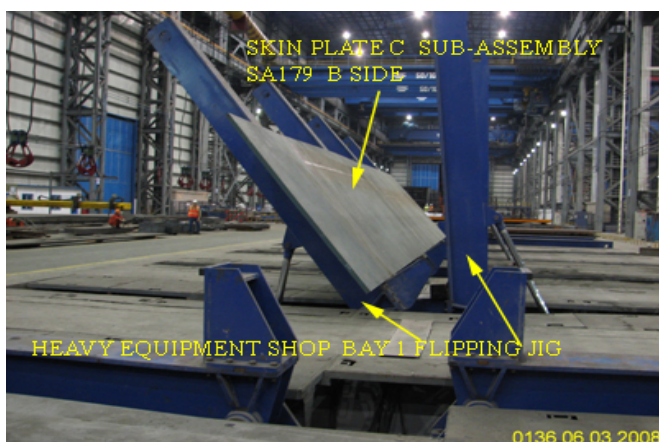
The QA Inspector randomly observed ZPMC personnel cutting off restraints and removing Tower Skin Plate C Sub-Assembly SA179(S) from the welding table to the flipping jig with an overhead crane. The QA Inspector then randomly observed ZPMC personnel utilizing the flipping jig to flip Tower Skin Plate C Sub-Assembly SA179(S) to the A side and then return to the welding table with an overhead crane, to allow for back gouging of WJ SSD1-SA179A/E-11B from the A side. The attached photographs provide additional detail.

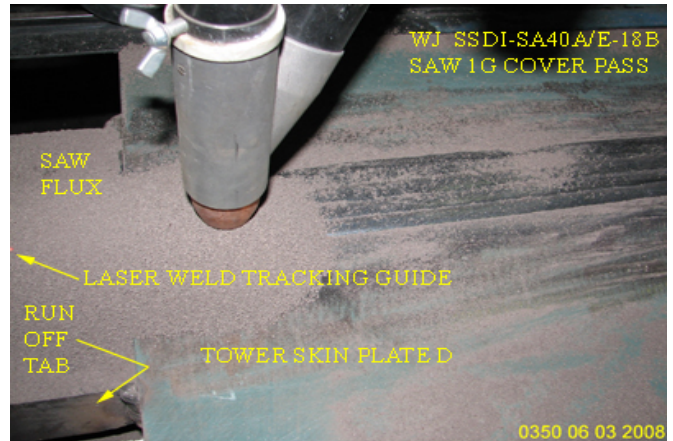
The QA Inspector randomly observed ZPMC welder Chen Hongxia ID Number 040460, utilizing the SAW Process in the 1G Position (Flat Groove) with ZPMC WPS WPS-B-T-2221-B-U3c-S, to weld the cover pass in WJ SSD1-SA40A/E-18B(CJP). The QA Inspector randomly observed ZPMC CWI Xu Le Feng monitoring weld parameters. The QA Inspector also randomly monitored weld parameters and recorded them as follows: 675 amps, 33 volts with a travel speed of 574 mm per minute. The weld parameters appeared to comply with contract requirements. The attached photograph provides additional detail.
